Evaluation of Nailed Roof-to-Wall Connections for Resistance to Uplift

National Association of Home Builders

**FINAL REPORT
August 2008**

Report #5822-04_081108

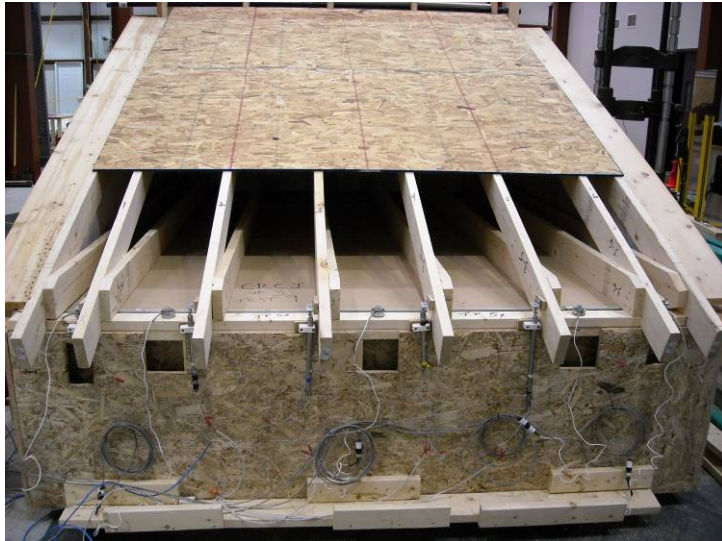
**Figure 4 – Uplift set-up instrumentation
(OSB panel is not attached to show connections and
instrumentation)**

Figures 4 and 5 show photos of the test setup. The specimens were subjected to a uniform uplift load applied using a pressurized 8-mil polyethylene bladder. The bladder was placed inside a structurally reinforced test box and the specimens were placed on top of the box to simulate typical roof conditions. The box was built using wood framing sheathed on both the interior and exterior faces with 7/8-inch-thick OSB.

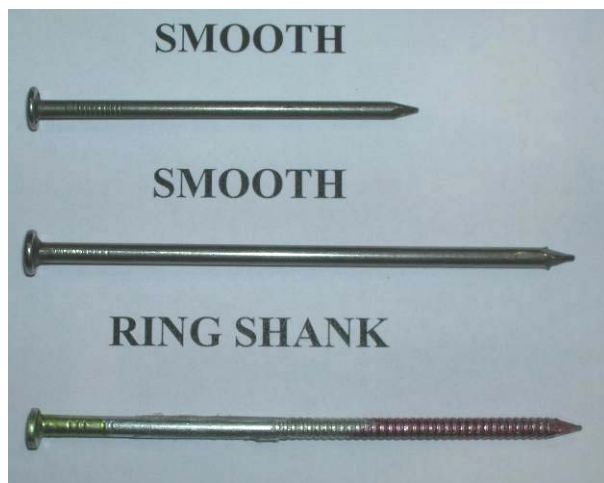
**Figure 6 – Pneumatic nails used in roof-to-plate
connections**

The smooth-shank pneumatic nails used in the roof-to-plate connections were manufactured by Senco and the ring-shank pneumatic nails were manufactured by Paslode (Figure 6). The smooth-shank nails had a symmetric full round head. The ring-shank nails had an asymmetric full round head (Figure 7). Because the IRC allows the use of smooth-shank common nails without coatings, all pneumatic smooth-shank nails were chemically cleaned of any adhesive prior to testing. The toe-nails were installed using a pneumatic nail gun at an angle approximately between 35 and 40 degrees off vertical and with the head of the nail located approximately 1/3 of the total nail length from the top plate (Figures 8 and 9). The location of the nail head is in accordance with the requirements of Section 11.1.5.4 of the National Design Specification for Wood Construction (NDS, 2006). The angle was slightly greater than 30 degrees recommended by the NDS because the weight and configuration of the nail gun made it difficult to position it at a 30-degree angle. It should be noted that some of the framing members did split during installation of the toe-nails. However, splitting to the extent shown in Figure 10 typically occurred in no more than one framing member per specimen.

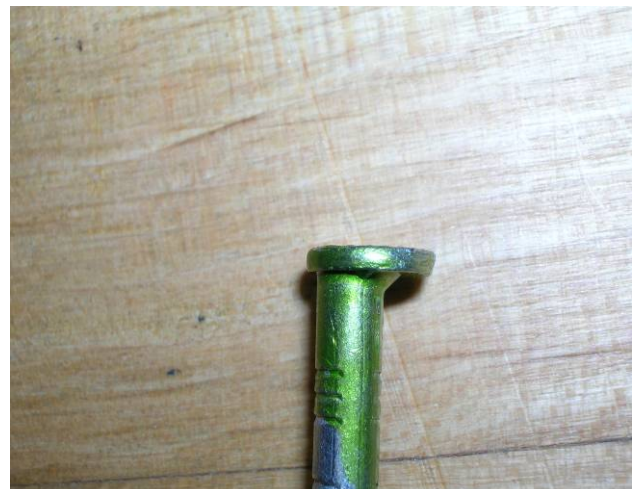
**Figure 7 – Asymmetrical full round head of
Paslode 16d ring-shank nails**

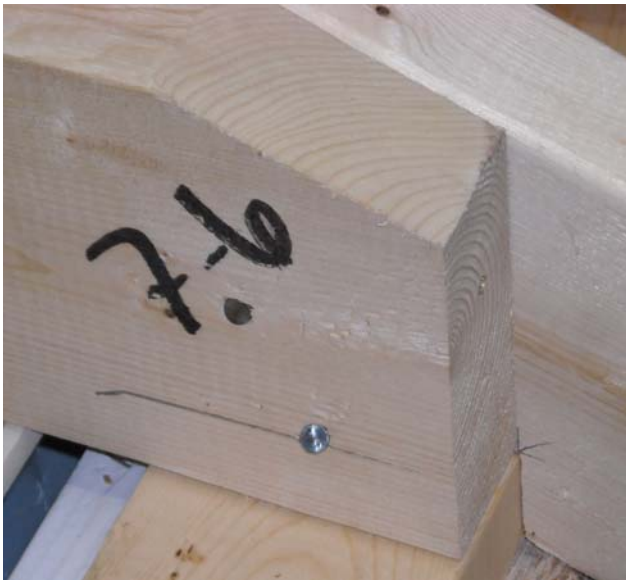
Figure 8 – Installation of toe-nails

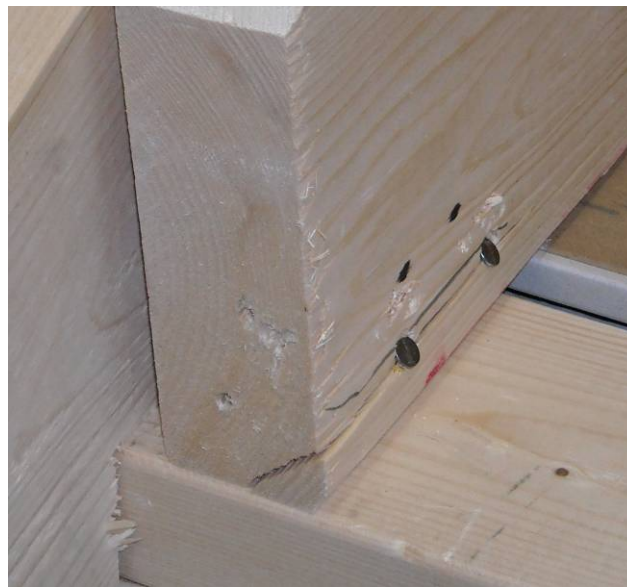
Figure 10 – Splitting of ceiling joist during installation of toe-nails

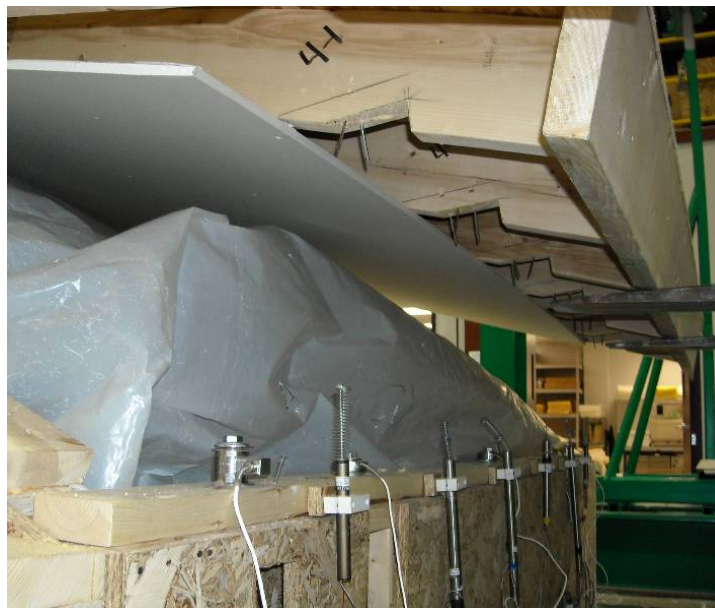
Figure 11 – Specimen after failure

The specimens failed in a manner that the entire roof system separated from the double top plate, i.e., it was a system failure rather than failure of individual connections (Figure 11). Load per connection was calculated by summing the load cell forces across the length of the top plate and dividing by the number of connections. It should be noted that peak loads for different load cells occurred at different times indicating a load redistribution mechanism between stronger and weaker connections. The maximum capacity of the system was taken as the highest total force resisted by the system (not the summation of the individual peak loads for each load cell).

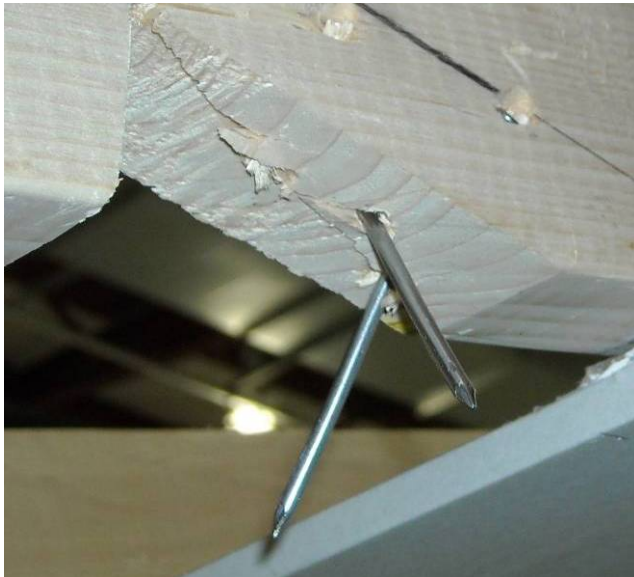
Figure 12 – Nail withdrawal and rafter splitting

Rafters were attached to the top plate using three 16d pneumatic box nails in accordance with RB207. The average capacity was 710 lb per connection. Figures 12 and 13 show typical failure modes including nail withdrawal from the top plate, pulling through the rafter, and rafter splitting. The predominant failure mode was nail withdrawal from the top plate. It is interesting to note that compared to specimens with a ceiling joist, rafter-to-wall connections are subject to both uplift and thrust forces. There was no evidence of reduction in capacity due to such loading. In fact, there is a potential for improved friction between the nail and the wood due to the force normal to the body of the nail.

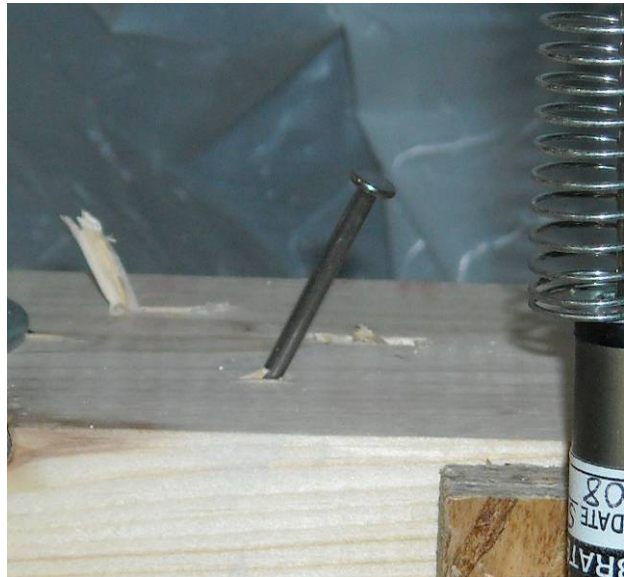
Figure 13 – Nail after pulling through rafter

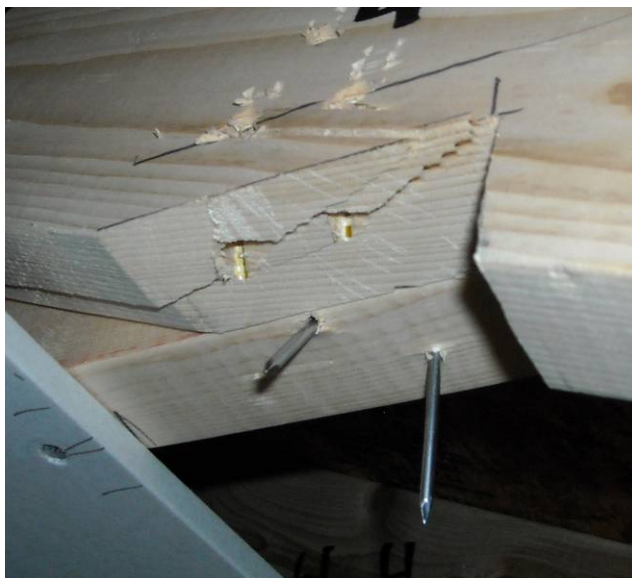
Figure 14 – Nail withdrawal of the 8d nails and pull through of 16d nails

The first configuration under this group is in accordance with the fastening schedule of RB207: three 8d box nails in the joist and two 16d box nails in the rafter. Figure 14 shows a typical failure mode that included withdrawal of 8d nails along with pull-through of 16d nails and splitting of the rafters. Although the total number of nails increased compared to the conventional rafter-only connection, the average capacity of this connection was 679 lb – a 4.4% reduction. This result indicates that 8d box nails do not have sufficient penetration into the top plate to develop comparable performance as 16d box nails even if normalized by length and diameter. As evidence, the safety margin relative to the allowable design values is reduced and is the lowest among all other tested connections that do not contain 8d nails (Table 2).

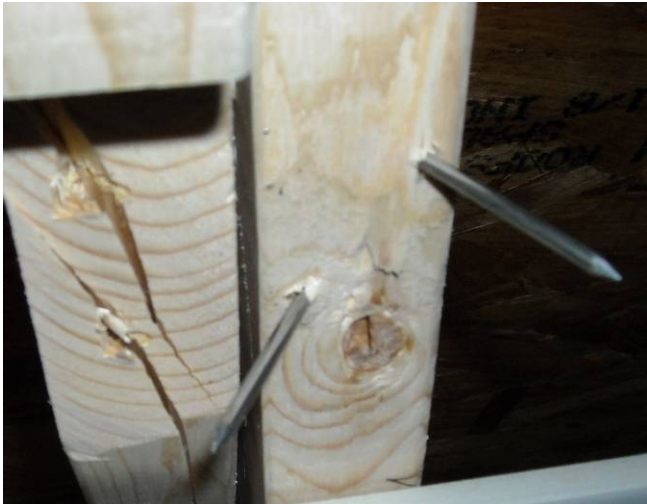
Figure 15 – Nail withdrawal and pull-through failure modes of 16d nails

In the second configuration under this group, the joists were attached to the top plate with two 16d box nails in lieu of three 8d box nails. Therefore, a total of four 16d nails were used per joint: two per rafter and two per joist. The intent for this configuration is to provide an alternative connection that uses a single nail type to allow for simplified construction. The typical failure mode for this configuration was a combination of withdrawal from the top plate along with pull-through and splitting of the roof member (Figures 15 & 16). The average connection capacity increased to 791 lb. The safety margins compared to the allowable design values have also increased. Although the total depth of penetration of three 8d box nails is greater than the total depth of penetration of two 16d box nails (4.6 inches for three 8d box vs. 4.3 inches for two 16d box), the total connection capacity using four 16d nails is 16% higher. This observation confirms the trend observed in the previous configuration that 8d box nails are less effective in toe-nail applications than 16d box.

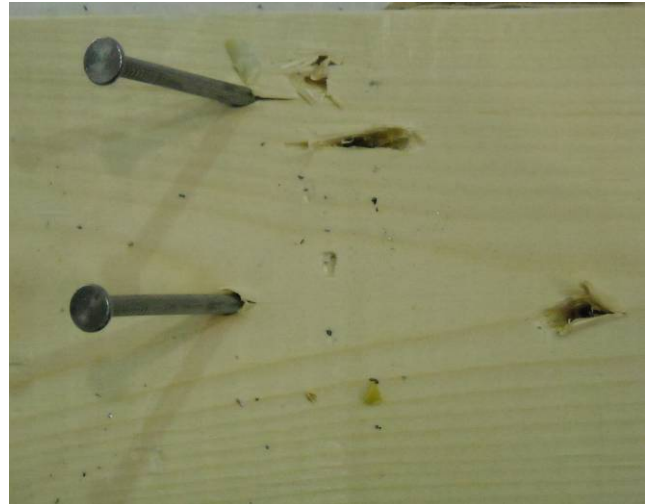
Figure 16 – 16d nails in plate after pull-through failure

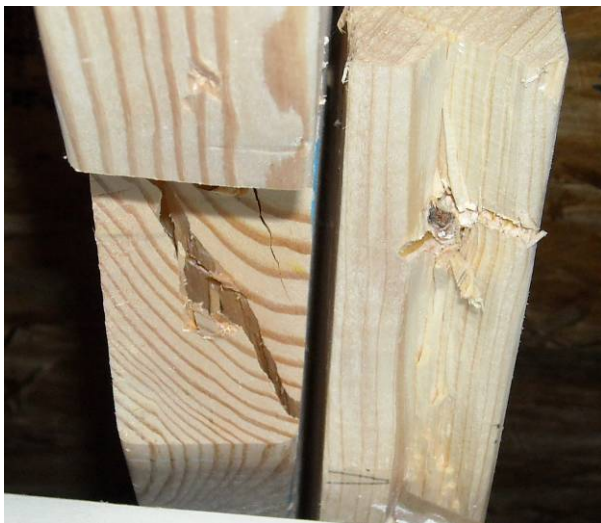
Figure 17 – Pull-through failure of all ring-shank nails

The third configuration under this group included testing of ring-shank nails. The intent of this configuration is to establish an upper bound capacity for toe-nailed connections. A total of four 16d box ring-shank nails were used to allow direct comparison with the previous configuration. The average capacity was 848 lb per connection, a 7.3% increase from the 16d box smooth shank results. The typical failure mode was associated with nails pulling through the roof members (Figures 17 & 18). Therefore, the limiting factor for the performance of ring-shank toe-nails is the capacity of the wood framing, capping the total connection's capacity at below 900 lb (the first test of this configuration reached 896 lb per connection). As previously noted, the ring-shank nails had an asymmetric round head configuration. It is possible that a different type of nail head can improve the pull-through performance.

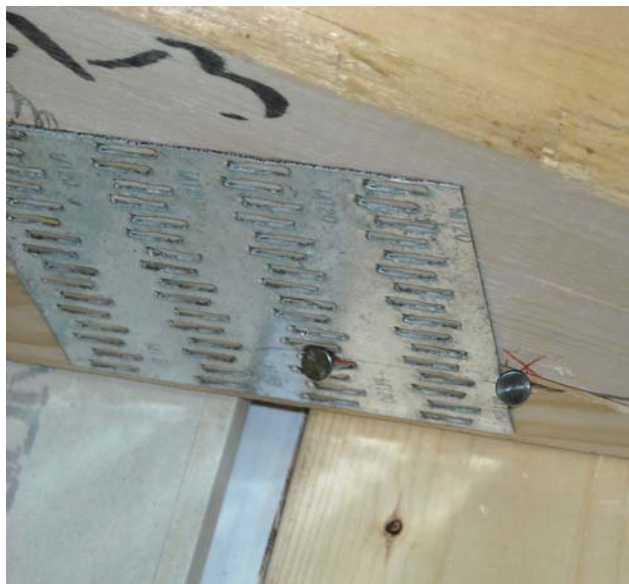
Figure 19 – Installation of one nail through the truss plate and one nail adjacent to the truss plate

One connection configuration of a MPC wood truss roof was tested using three 16d box nails in accordance with RB207. Because this connection is affected by the location of the truss plate relative to wood framing, the truss heel joint was selected such that the location and size of the truss plate allowed for two nails be driven through the truss and one nail directly through the wood (Figure 19). This configuration allowed to capture the effect of a nail located near the end grain of the beveled edge, which has a potential propensity to splitting. Figure 20 shows the typical failure mode that included withdrawal of the nails from the top plate. The metal truss plates reinforced the wood of the bottom chord minimizing the potential for wood splitting and eliminating the nail pull-through failure mode. Even where local splitting of the bottom chord occurred near the nail installed at the beveled edge, the truss plate was effective at keeping the wood member together such that all nails withdrew from the top plate. The capacity of the truss-to-roof connection was 671 lb per joint, a 5.5% reduction relative to a three 16d box nail connection for conventional rafters. However, the performance of the two configurations is considered equivalent, as this reduction can be attributed primarily to the increased framing spacing of 24 inches on center. This increased spacing contributed to reduced stiffness of the boundary conditions at the edge trusses due to the increased width of the free edge (12 inches for trussed spaced at 24 inches on center vs. 8 inches for framing spaced at 16 inches on center). In a complete roof assembly, the sheathing is either continuous or attached to boundary members, resulting in increased boundary stiffness.

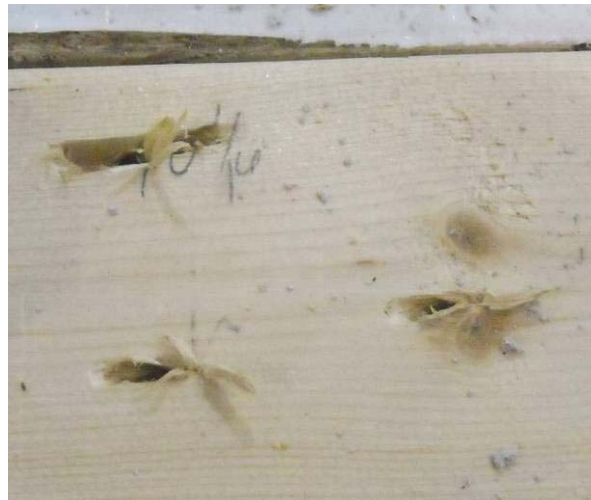
Figure 21 – Local tearing/crushing of top plate associated with withdrawal failure mode

Where the primary failure mode was withdrawal of the nails from the top plate, the wood around the nail was subject to crushing and tearing to allow for withdrawal of an angled nail to occur (Figure 21). This response mode should also in part explain the improved performance of 16d nails vs. 8d nails – the longer nails have an increased horizontal projection engaging more wood to resist tearing. This toe-nail response is different from a straight nail pullout where the resistance is controlled only by the friction between the nail and the wood fibers.
